Next Generation Damage and Post-Crisis Needs Assessment Tool for Reconstruction and Recovery Planning
Capability Project

RECONASS - The Pilot Test
Where: Älvdalen, Sweden
When: 25th and 30th of August 2016
Who: RECONASS Consortium

1 THE PILOT TEST STORYLINE

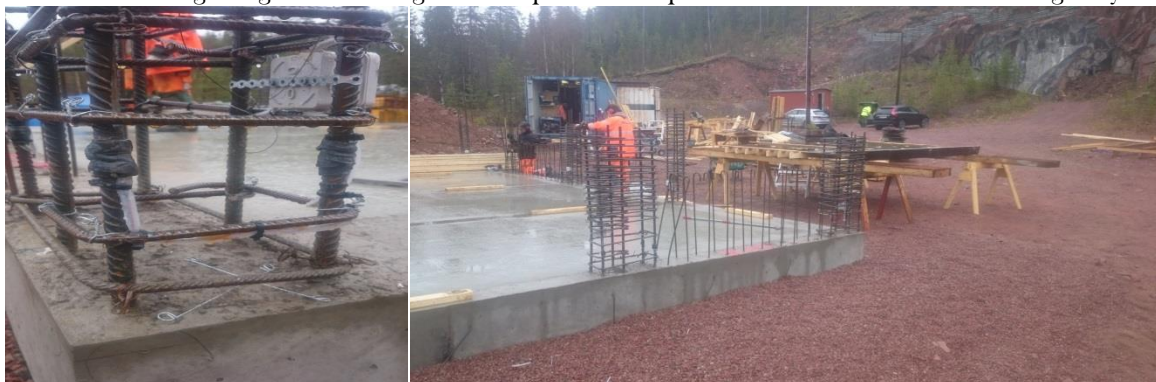
Strain sensors installation to the building's rebars

Since the start of the pilot building's erection, Phase A of the instrumentation began. During that time and when the foundations were constructed the strain sensors have been installed in the rebars so that the building's loadings are monitored both during its erection (dead load) but during operations as well. For the latter, the strain values provide assessment to the buildings fatigue. The images below present the placement of strain sensors during May 2016.

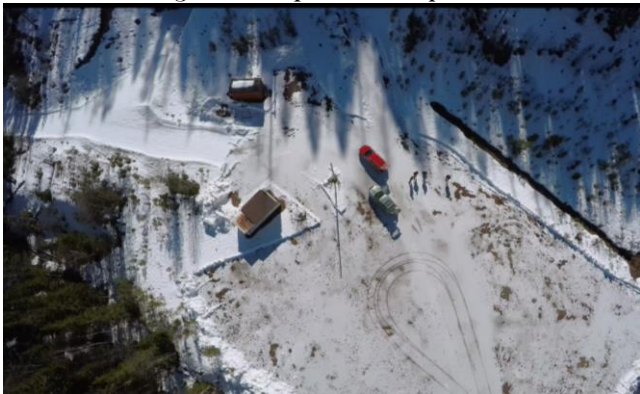
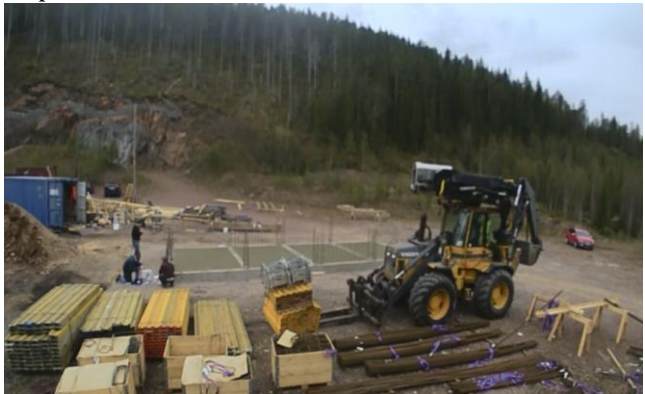
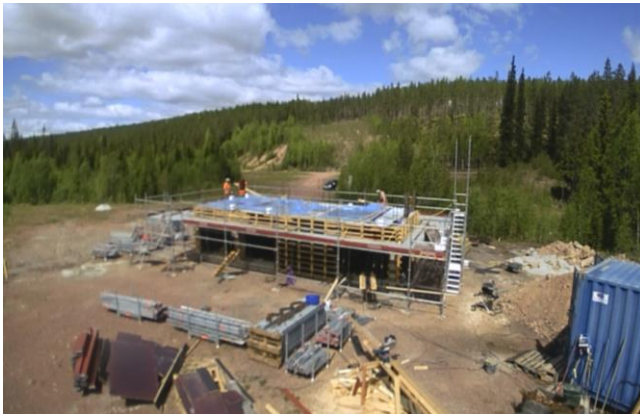
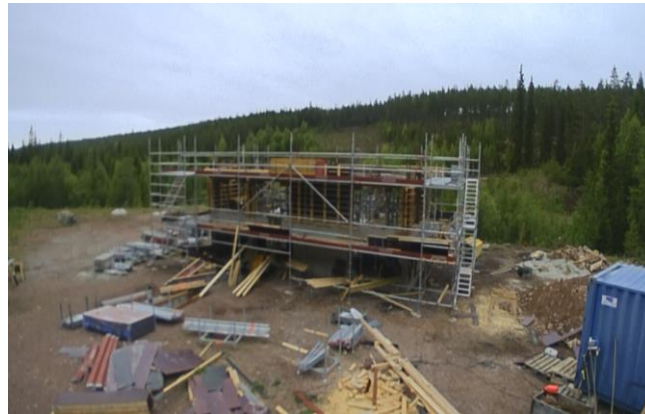
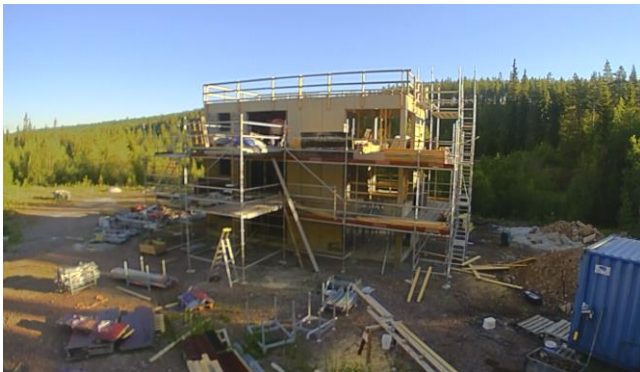
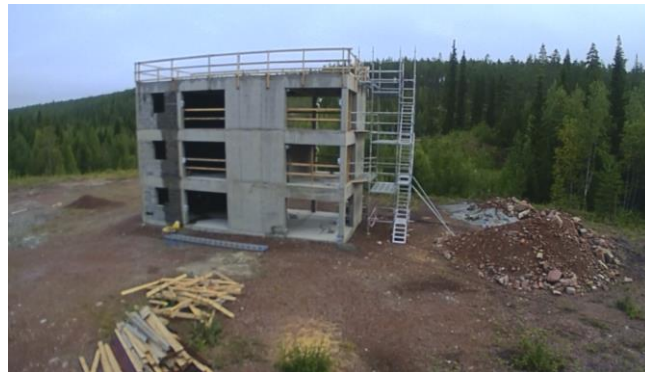
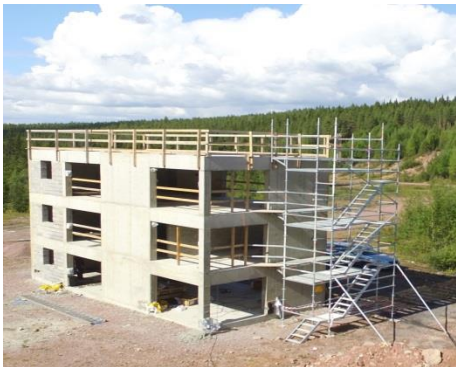
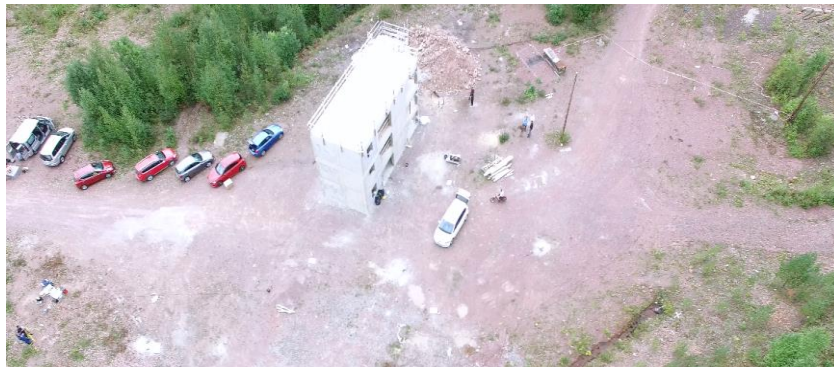
The RECONASS building took its final shape, from setting the foundations to final construction after a 3.5-month process. The building was ready to be fully instrumented by the RECONASS monitoring system around end of July 2016. The images below provide snapshots of the erection process.

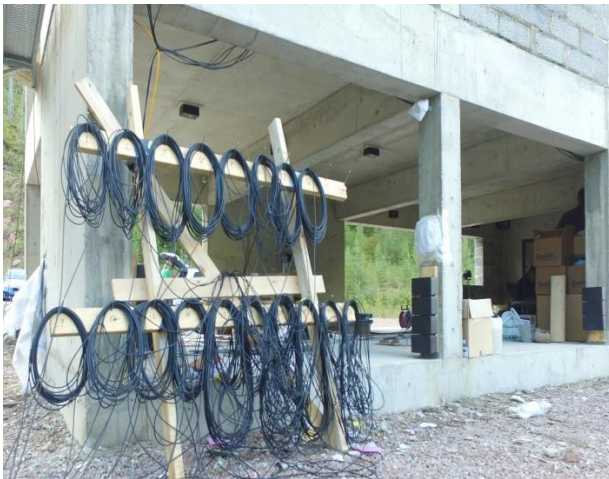
Ready to cable high frequency sensors (left) & the strain wireless module (right)

Furthermore, additional instrumentation means¹ have been deployed: a) A laser scanning/total GPS base station system has been set in place so as to measure the building's reactions to blast with mm accuracy; providing an additional evaluation metric for the RECONASS system. And b) high-frequency accelerometers and pressure gauges have been also installed so as to measure the pressure wave and the blast impact subjected to the building.

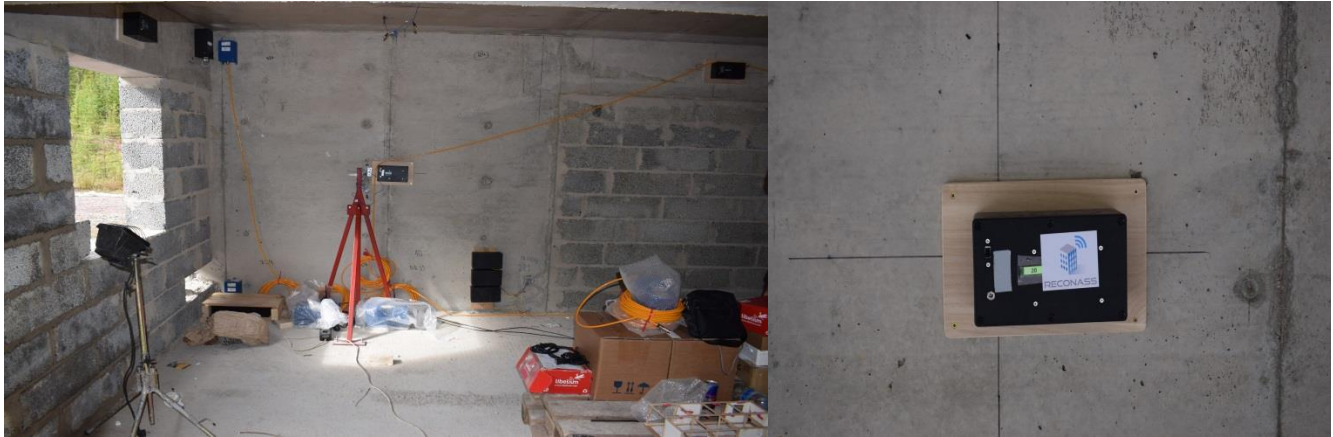
Set up of data hubs, temperature sensors and accelerometers at ground floor (left) & the positioning tag at the mid-span of a wall (right)

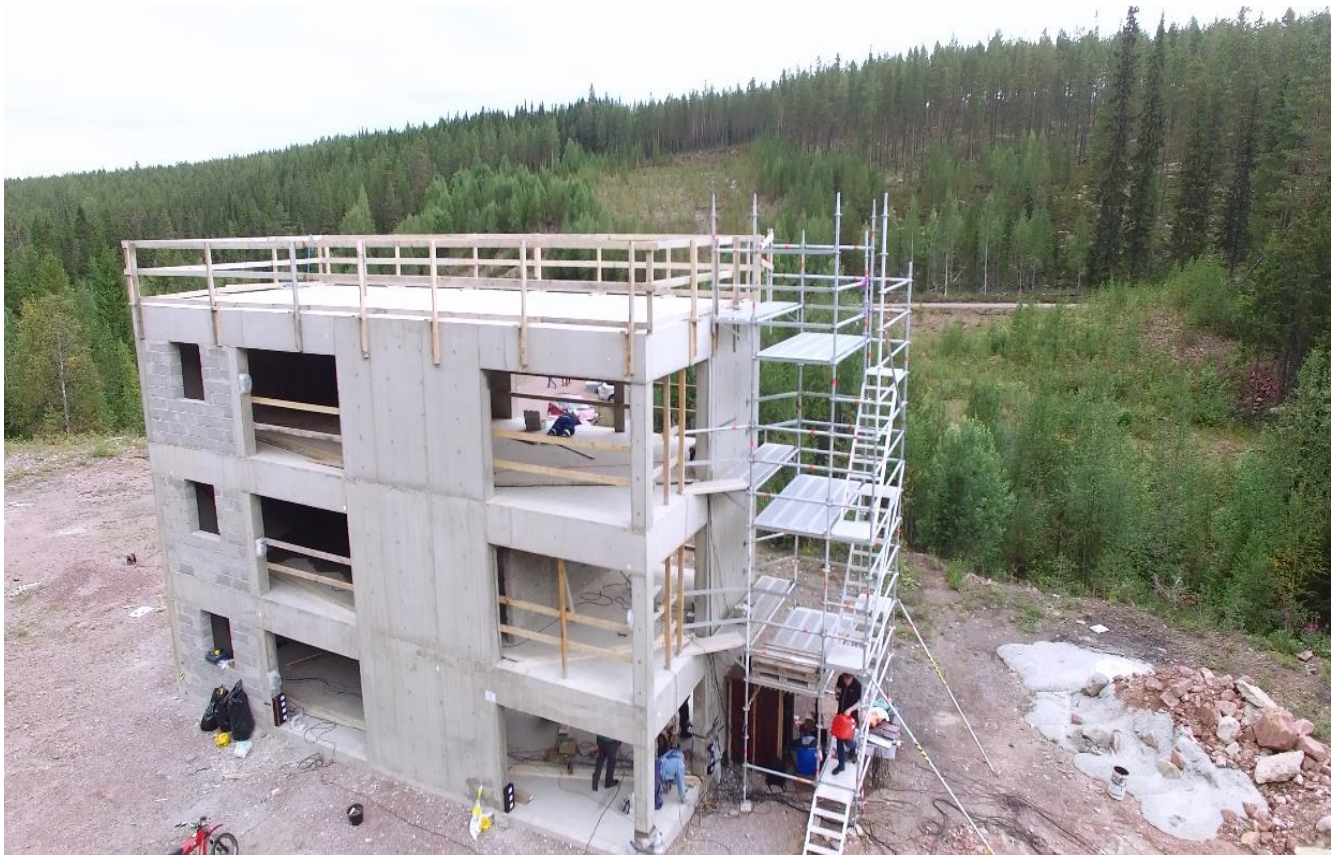
Busy day on site - all RECONASS partners are instrumenting the building in preparation for 1st explosion

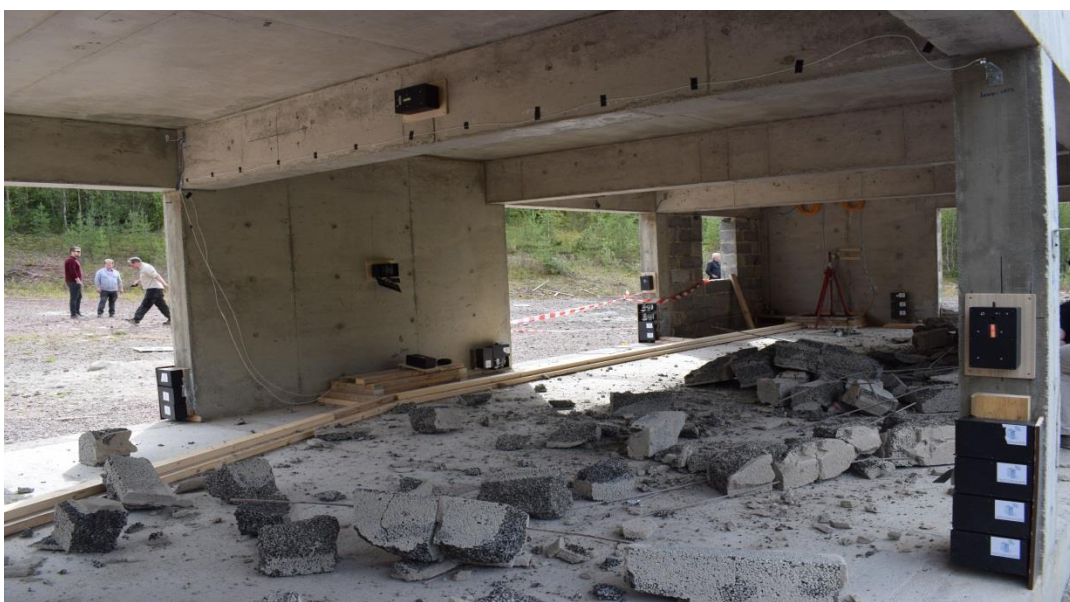
After the external blast the RECONASS system remained operational with minor losses of components that did not affect the assessment process. The images below depict the building and the instruments' status as well as the first results visualised by the RECONASS platform (PCCDN). The building remained safe!

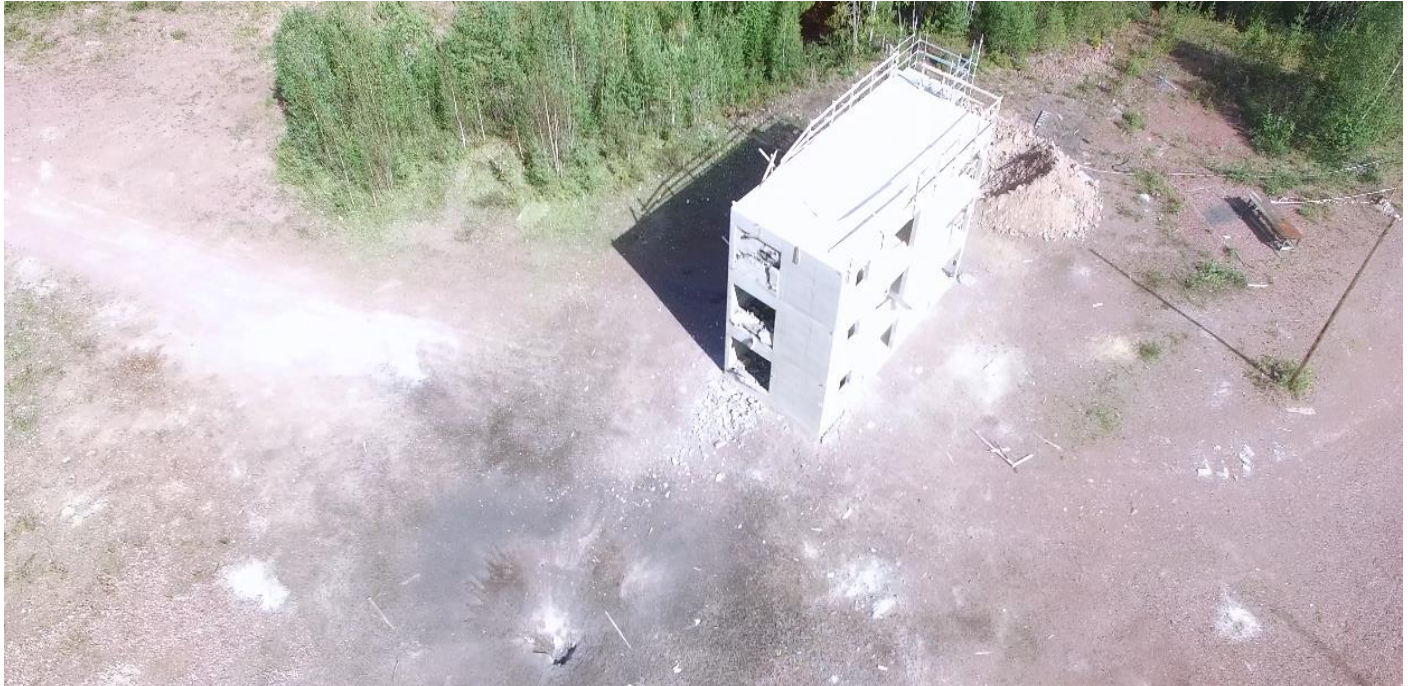
PCCDN Tool Results after 1st Explosion (combination of manual/automatic/aerial data)

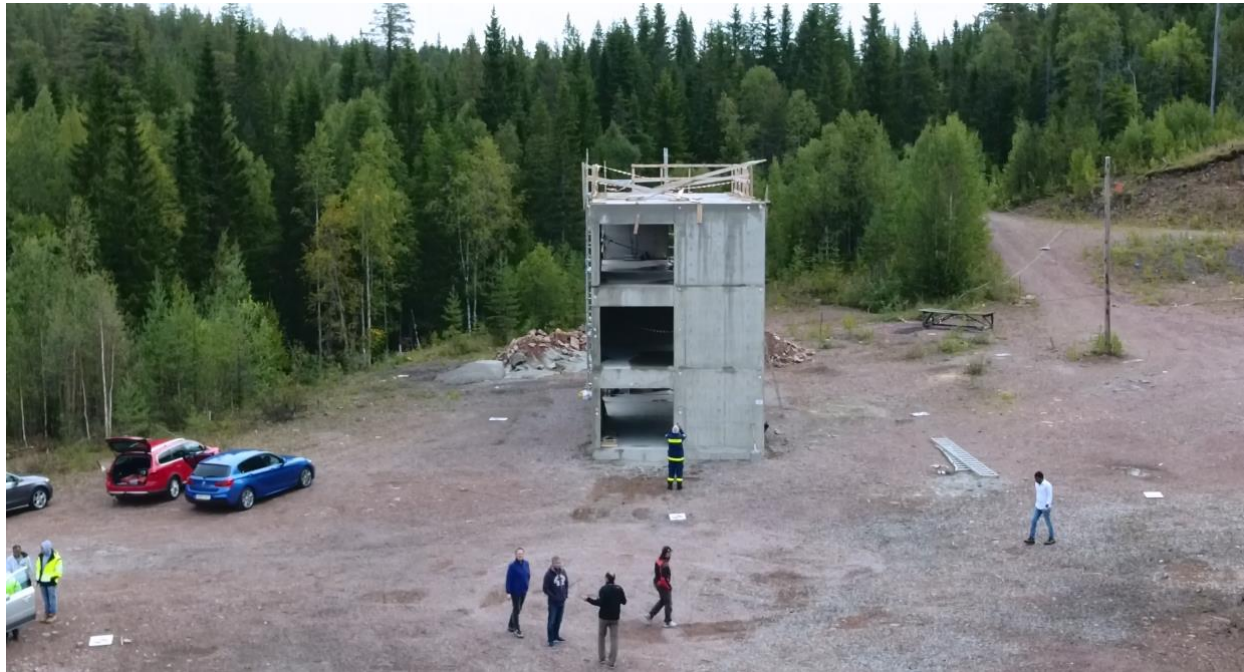
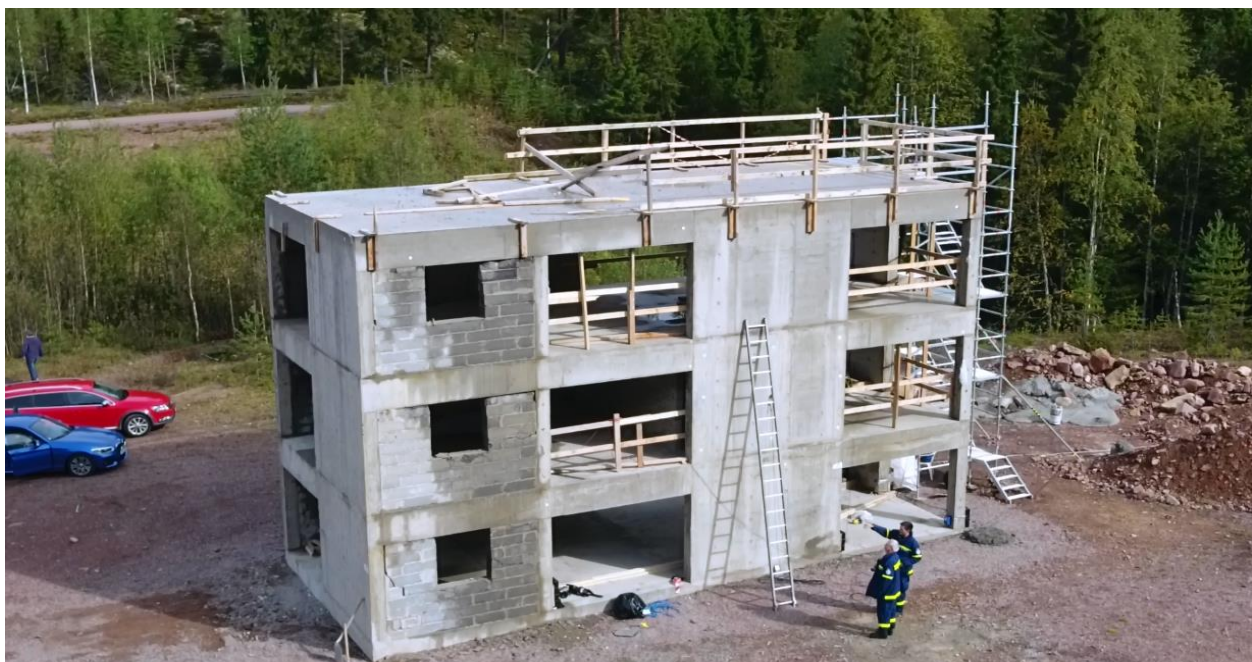
On 30th of August the 2nd test, this time an internal blast with 16 Kg of TNT, was executed. Between the two tests the system remained operational and minor equipment failures from the first test were corrected. Furthermore a “hot” evaluation of the individual components of RECONASS system as well as of the assessment results has been performed by the partners. The 2nd explosion was closed to the public and only the consortium attended the test. The images below depict the preparation process for the internal explosion as well as the post-event conditions.

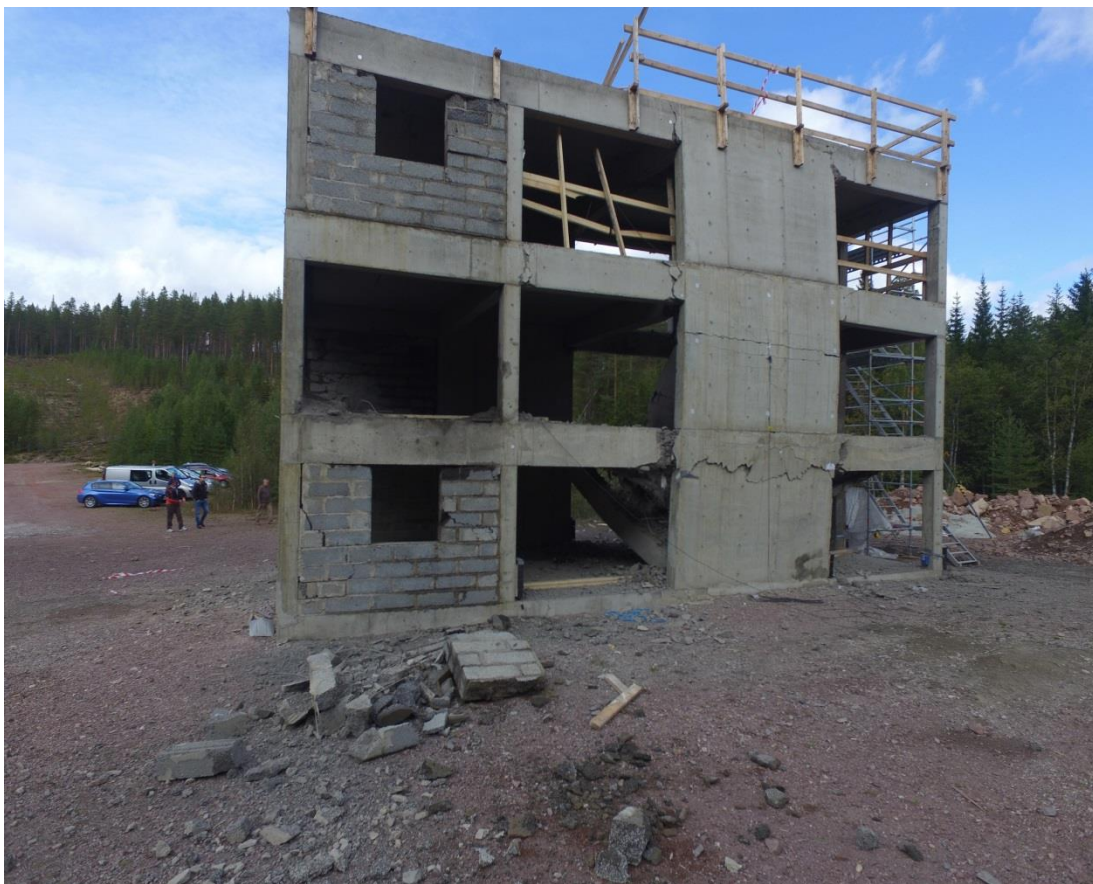
Pilot building's condition after internal blast (floor collapsed and external walls/columns were severely displaced)

The internal blast was severe to the building (as anticipated/simulated) and some losses of components occurred. However, the system remained (partially) operational as individual sensors failed and it was able to provide, via the absence of data from particular sensors, the assessment that the building was not in a structurally safe condition for certain areas.

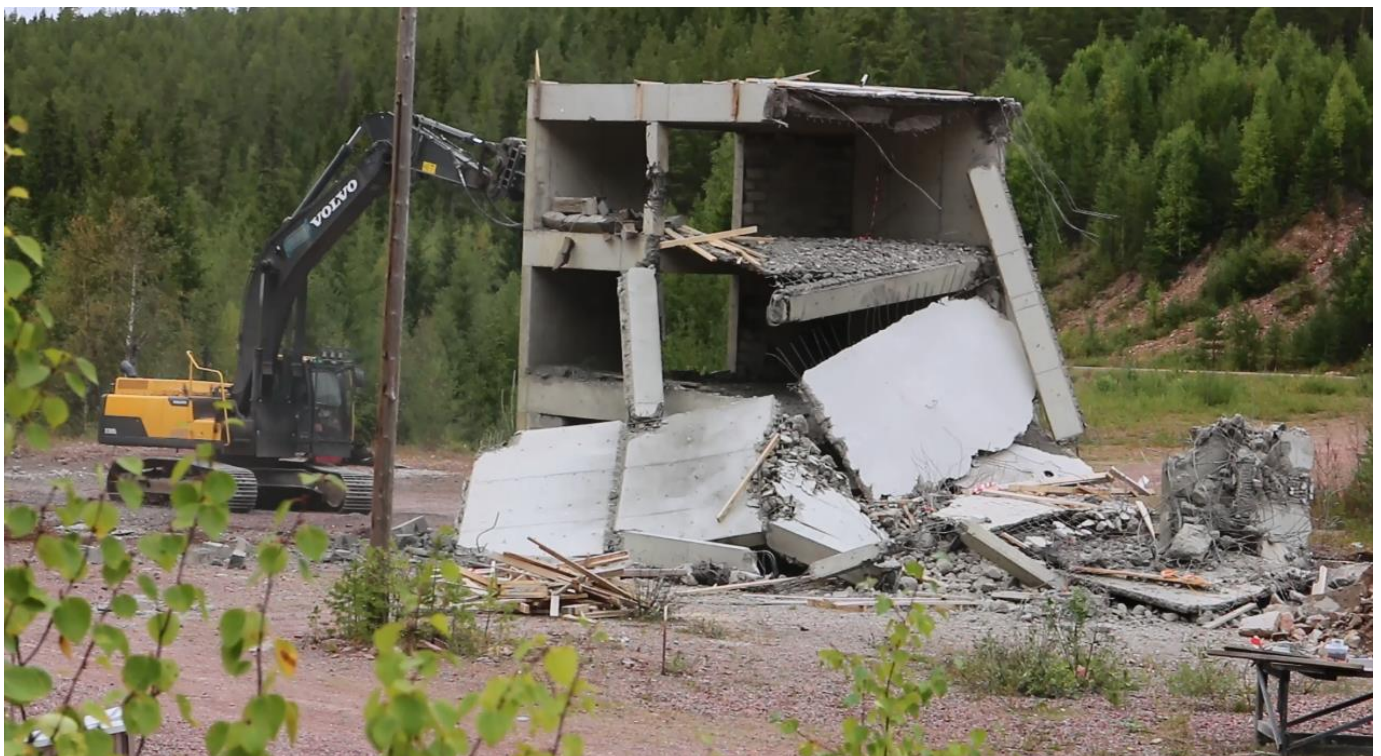
After pilot conclusion (building was demolished and functional equipment retrieved)
