RECONASS Newsletter

Reconstruction and REcovery Planning:
Rapid and Continuously Updated
CONstruction Damage
and Related Needs ASSEssment

The Pilot Test in Sweden

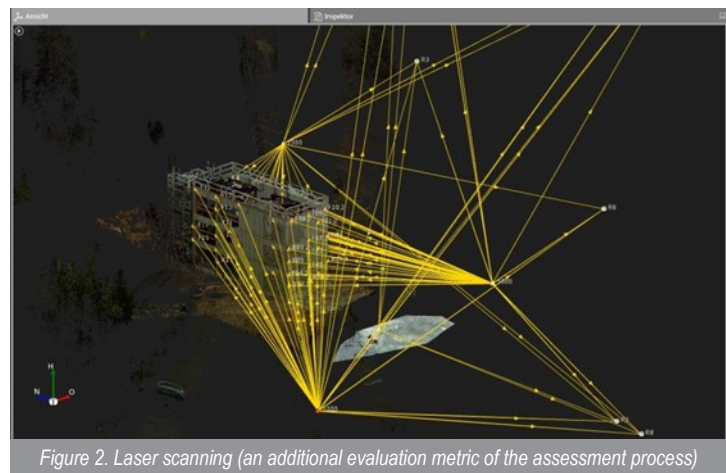
Figure 2. Laser scanning (an additional evaluation metric of the assessment process)

Furthermore, additional instrumentation means have been deployed to assess the system, including: a) A laser scanning/total GPS base station system to measure the building's reactions to blast with mm accuracy (see Fig. 2); and b) high-frequency accelerometers and pressure gauges to measure the pressure wave and the blast impact subjected to the building.

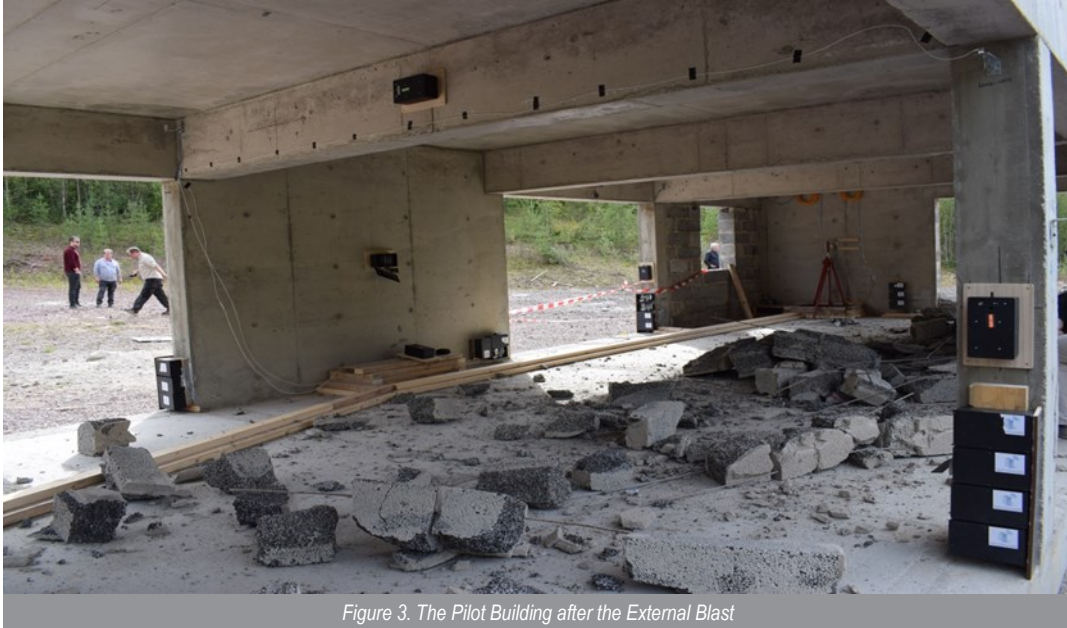
Figure 3. The Pilot Building after the External Blast

On August 25 there was a 400 Kg of TNT external blast, after which the RECONASS system remained operational with minor losses of components that did not affect the assessment process. The image in Fig. 3 depicts the building and the instruments' status. The building remained safe!

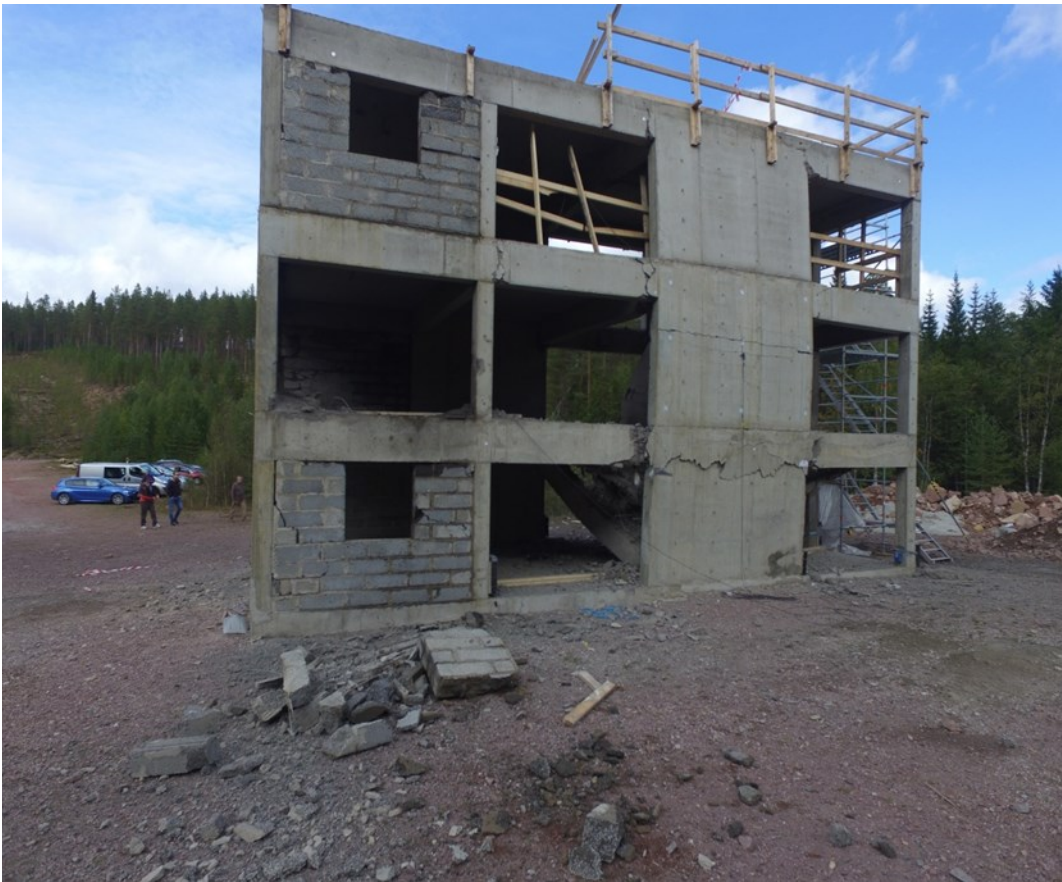
Figure 4. Pilot building's condition after internal blast (floor collapsed and external walls/columns were severely displaced)

On August 30 an internal blast with 16 Kg of TNT, was executed which was severe to the building (as anticipated/simulated) and some losses of components occurred. However, the monitoring system remained (partially) operational as, even though individual sensors failed, it was able to provide, via the absence of data from particular sensors, the assessment that the building was not in a structurally safe condition for certain areas.

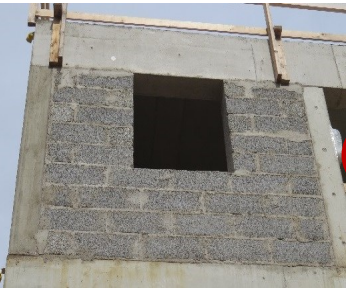
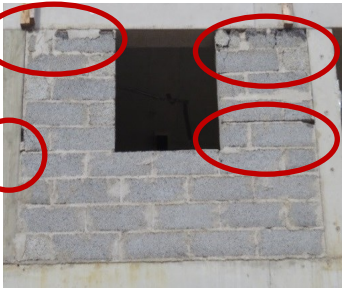
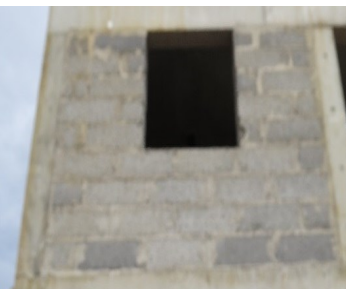
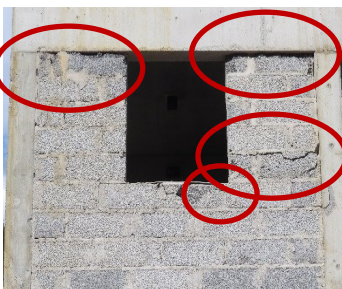
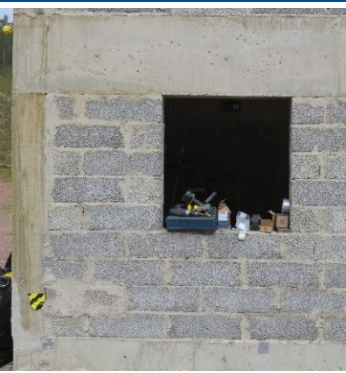
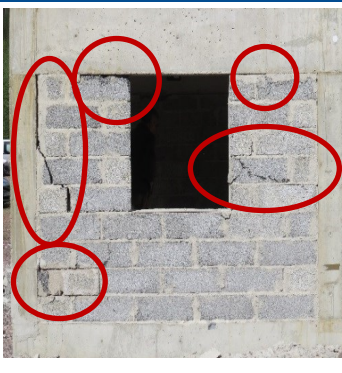
Fig. 13 shows the damages after the blast and the damages states calculated by the Module as described in the taxonomy which they are in good agreement.

DS B2011.001.2 - MODERATE Cracks in mortar and wall finishes	DS B2011.001.3 - INTENSIVE Repair action: Some parts of the wall may need demolition and reconstruction. Also the damaged area needs the repair of exterior finish Functionality Level: Partially functioning Debris : 0,56 m ³
2

DS B2011.001.3 - INTENSIVE Severe cracks in the wall (X-diagonal shear cracks) and spalling of wall finishes	DS B2011.001.3 - INTENSIVE Repair action: Some parts of the wall may need demolition and reconstruction. Also the damaged area needs the repair of exterior finish Functionality Level: Partially functioning Debris : 0,56 m ³
1

DS B2011.001.3 - INTENSIVE Severe cracks in the wall (X-diagonal shear cracks) and spalling of wall finishes	DS B2011.001.3 - INTENSIVE Repair action: Some parts of the wall may need demolition and reconstruction. Also the damaged area needs the repair of exterior finish Functionality Level: Partially functioning Debris : 0,56 m ³

Figure 13 Actual and Calculated Damages in Non-Structural Components after the External Blast

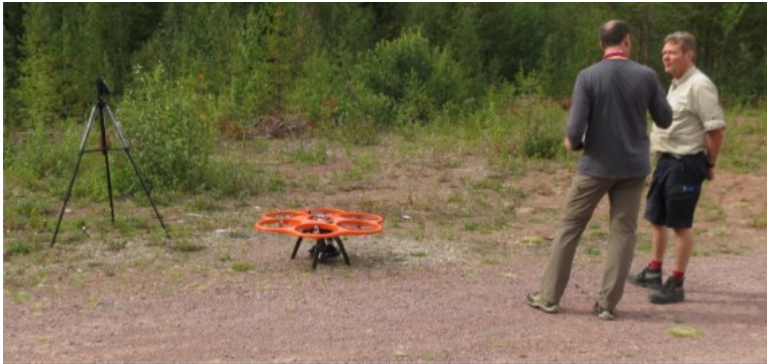
Figure 17 Aibotix Aibot X6 V2 (left), and circular layout of images (right).

The images were captured using an Aibotix Aibot X6 V2 UAV (Fig. 17) with an average ground sampling distance (GSD, pixel size at the object) of 1.5 cm. In total 103 images were captured. The acquisition went quite smoothly – the circles were flown within 4 minutes (cf. Fig. 17). The captured images were copied to a laptop computer and the so-called image orientation and calibration was performed. Subsequently, the 3D point cloud was generated, which is the input for the damage assessment module.
